# Water Quality Concern for Kalamazoo River Tributary Streambed Restoration

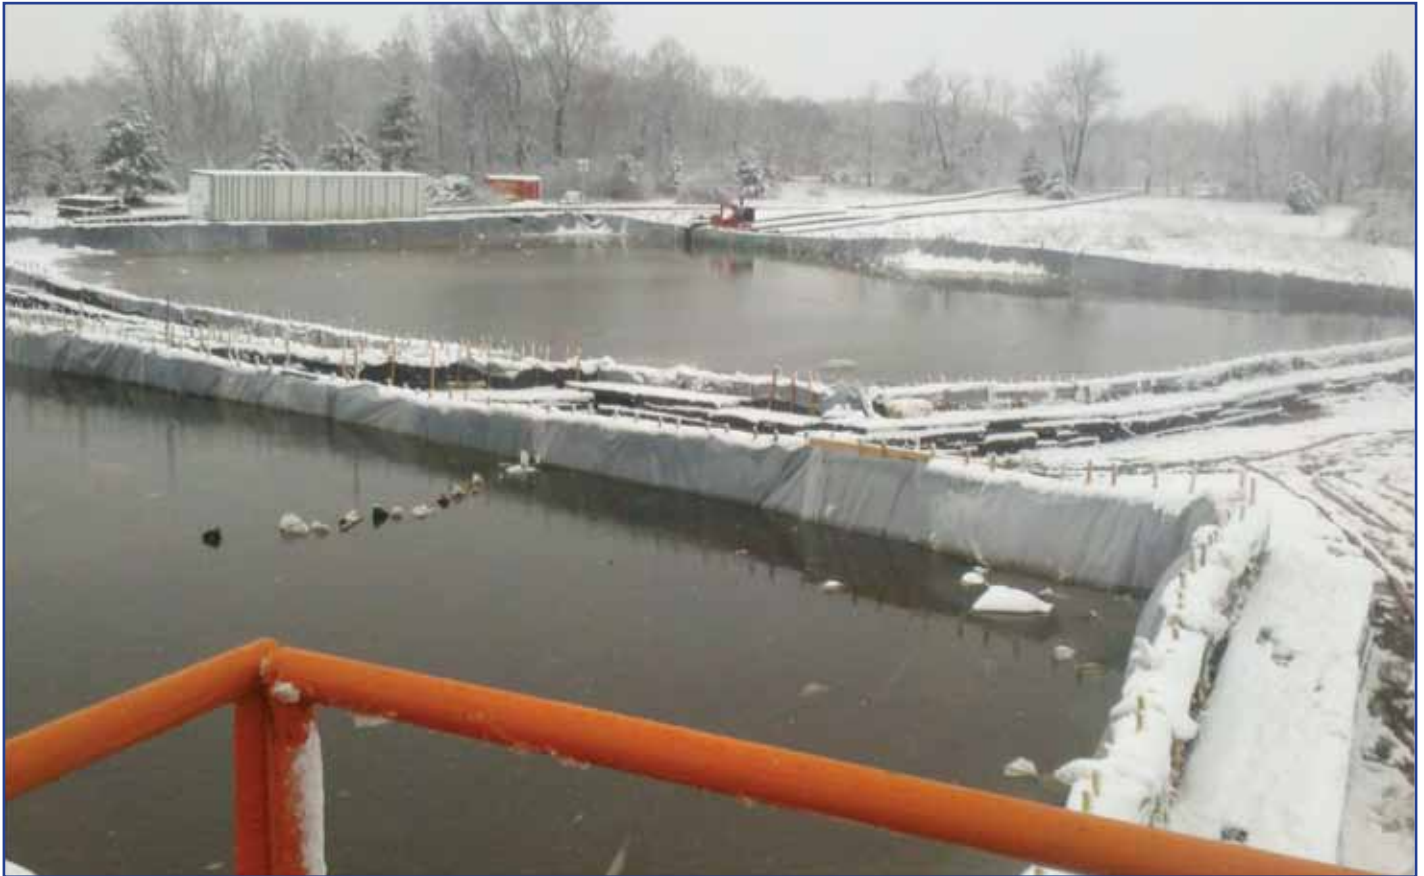
**View of ponds from the top of container based water treatment and clarification system.**

Interface H2O provided a conceptual design plan for two settlement ponds, each 0.8 acres and operating depths of 3 feet (aprox. 750,000 gallons each). Each settlement pond was designed to slow water flow rate to maximize flocculent settling and capture. In the narrow conveyance connecting the two ponds, jute net capture devices were installed to enhance flocculent capture during flood stage pumping.

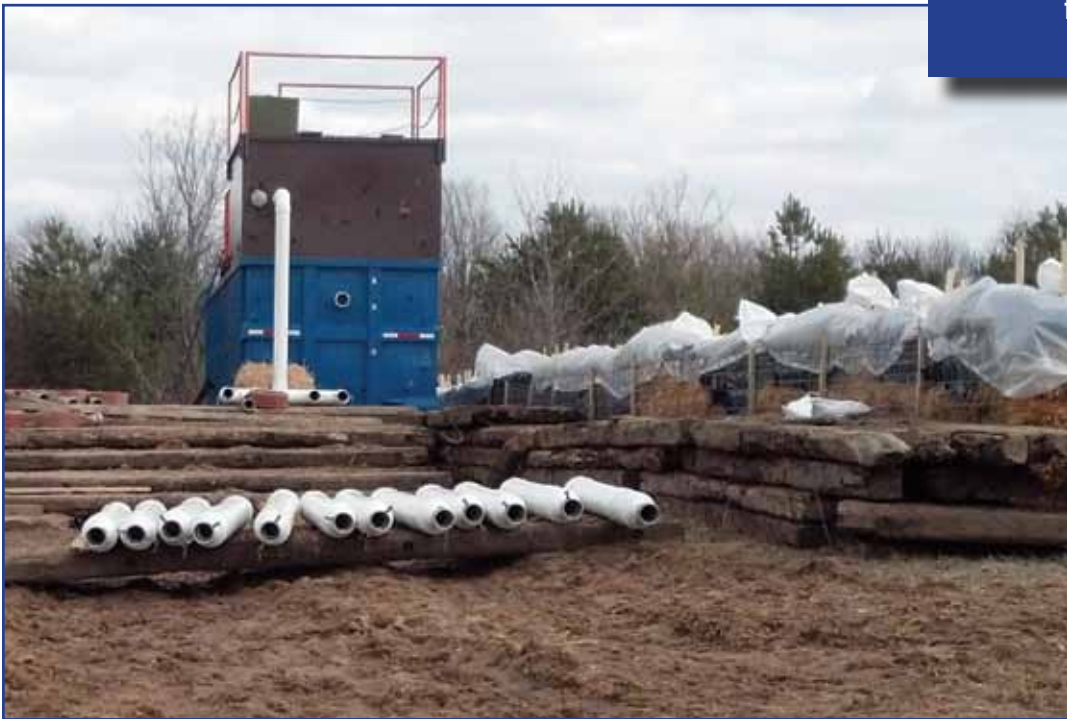
**Water Matrix setup next to pond #1 with first bank of Floc Hogs.**

place at the head of the first settlement pond where it directly discharged. The container was supplied by four 4" lines, each containing two Floc Hogs in series. They were separated by 100' of 4" hose and were connected to an inflow manifold which in turn was connected to the 18" inflow pipe supplied by the contractor. This system could effectively treat the routine pumping rate of 1500 GPM.

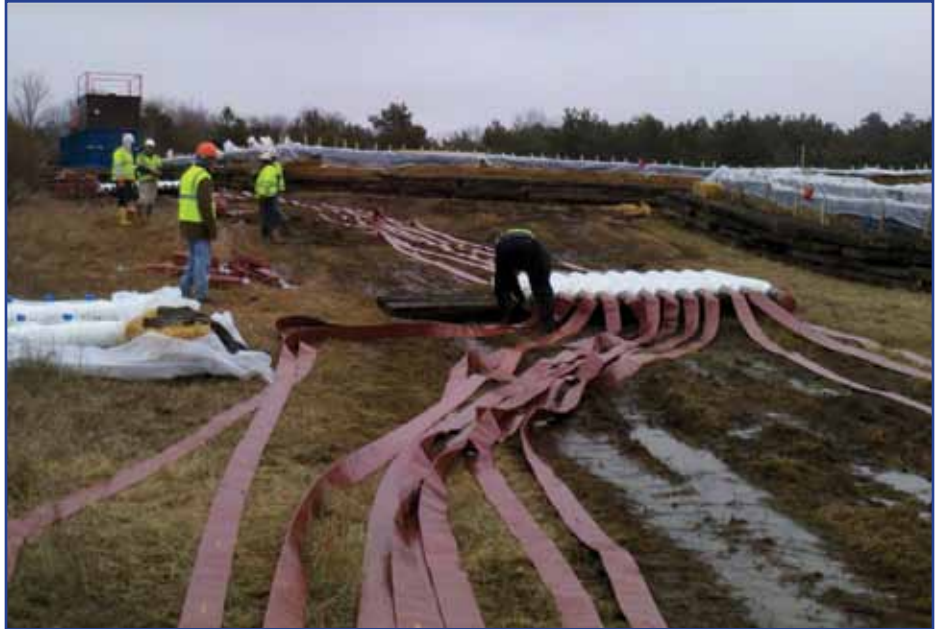
**Floc Hogs installed with 100' of hose between banks.**

For flood stage pumping, an additional eight 4" lines were provided from the inflow manifold. Each line had two Floc Hogs in series separated by 100' of 4" hose. These discharged directly into the first settlement pond. A series of valves served to open or close these flood control lines as needed.

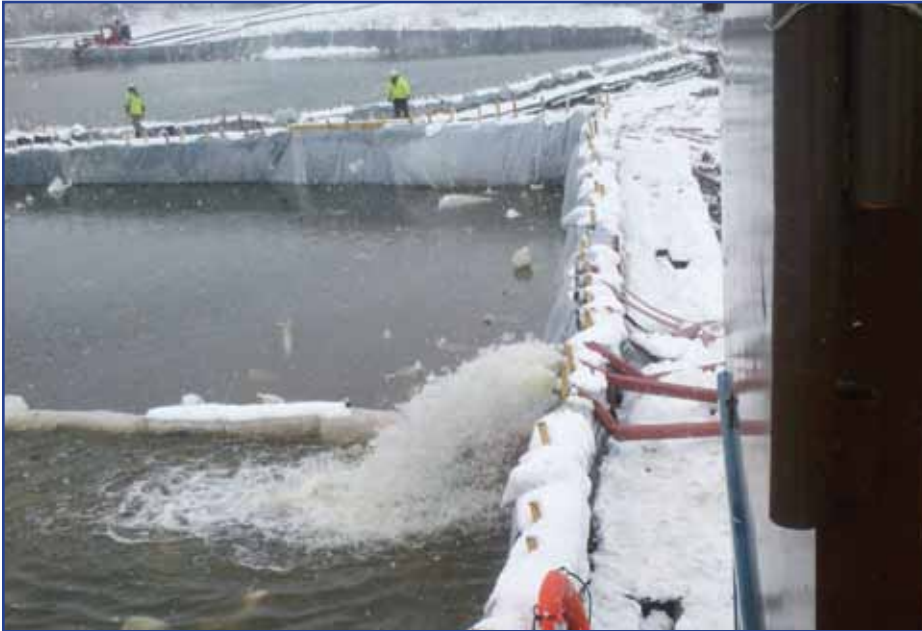
**4 lines opened for flood control.**
